CSL Ref: 2013-06LREP 13th September, 2013

The CEO Kapiti Coast District Council 175 Rimu Road PARAPARAUMU

Erosion Hazard Reassessment: northern shoreline of Waimeha Inlet

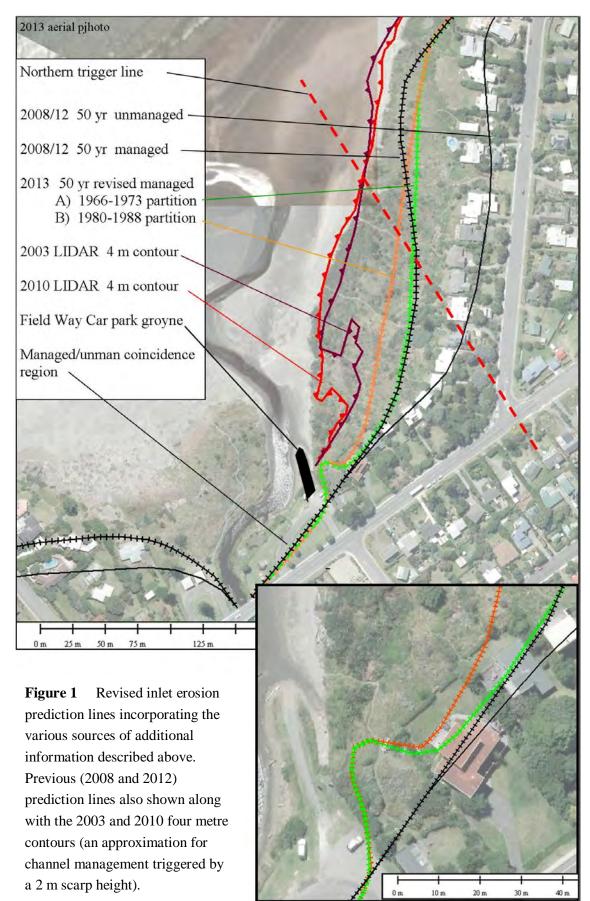
To appreciate the effect of the 2 m escarpment trigger condition on the northern inlet, the 4 metre contour was defined from 2003 and 2010 LIDAR and these are plotted in Figure 1. The 4 metre contour was selected as the typical scarp base associated with channel scour is approximately 2 metres above MSL. These results show that only about 10 % of the 2003 and 2010 four metre contours actually correspond, i.e. no change. Along the outer inlet the 4 metre contour moved landward by up to 10 m during the 2003 to 2010 period, along the mid inlet the contour moved seaward by up to 10 m, and within the inner inlet the contour moved seaward up to 30 m.

The revised 50 yr managed inlet erosion prediction line based on 1973 to 2013 shoreline analysis and incorporating the various sources of additional information described above is shown by the green crossed line in Figure 1. Note that the associated inlet migration curve is depicted in Figure 2 (red racked line). For comparison the 2008 and 2012 managed 50 yr erosion prediction line is also depicted in Figure 1 (black crossed line). There are several differences between the revised and earlier erosion prediction lines and these are now described.

The coincidence of 50 yr managed and unmanaged erosion prediction lines in the 2008 and 2012 assessments occurred along the back of the inlet (indicated in Figure 1) due to there being minimal variation in landwardmost shoreline variation between the unmanaged shorelines (1942 to 1966) are the managed set (1973 to 2007). The associated inlet migration-curves for both unmanaged and managed are coincidental and thus the final erosion prediction lines also coincide. However, as can be seen in Figure 1, the revised 50 yr managed prediction line does show some variation to the unmanaged

prediction line; this being due firstly to incorporation of the car park groyne influence which, downstream of the structure, offsets the managed prediction line seaward. And secondly, immediately upstream of the groyne, the managed line is a few metres landward, this latter modification being due to a more accurate determination of the 1988 shoreline.

- 1) That long-term environmental implications of the present inlet management (erosion) regime be assessed, and
- 2) That the 50 yr managed erosion inlet line be that based upon analysis of the revised 1966/1973 partitioned shoreline data set.

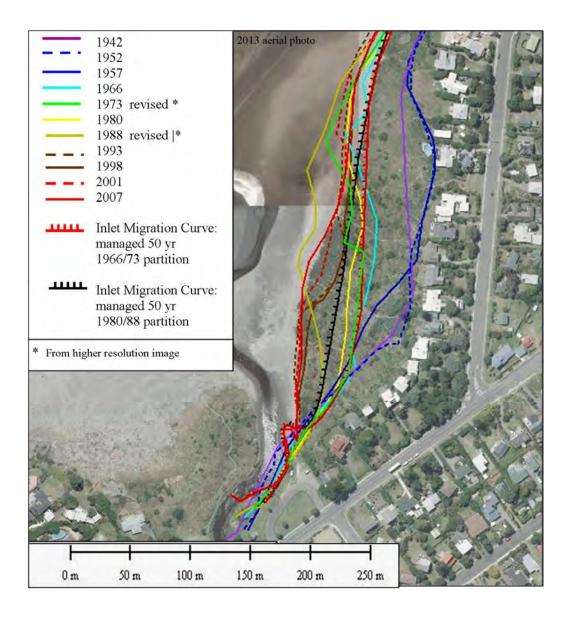
The 1973 and 1988 aerial photo-based inlet shorelines used for the previous assessments were of poor quality so improved imagery was acquired, processed and shorelines abstracted. In addition, as the 2010 and 2013 aerial images are now available, these samples were also processed and shorelines defined. Figure 2 depicts the revised set of shorelines which were then incorporated within the inlet erosion remodelling.
