CSL Ref: 2013-14LREP
15 November, 2013

Erosion hazard assessment for the Mangone Inlet using managed scenarios

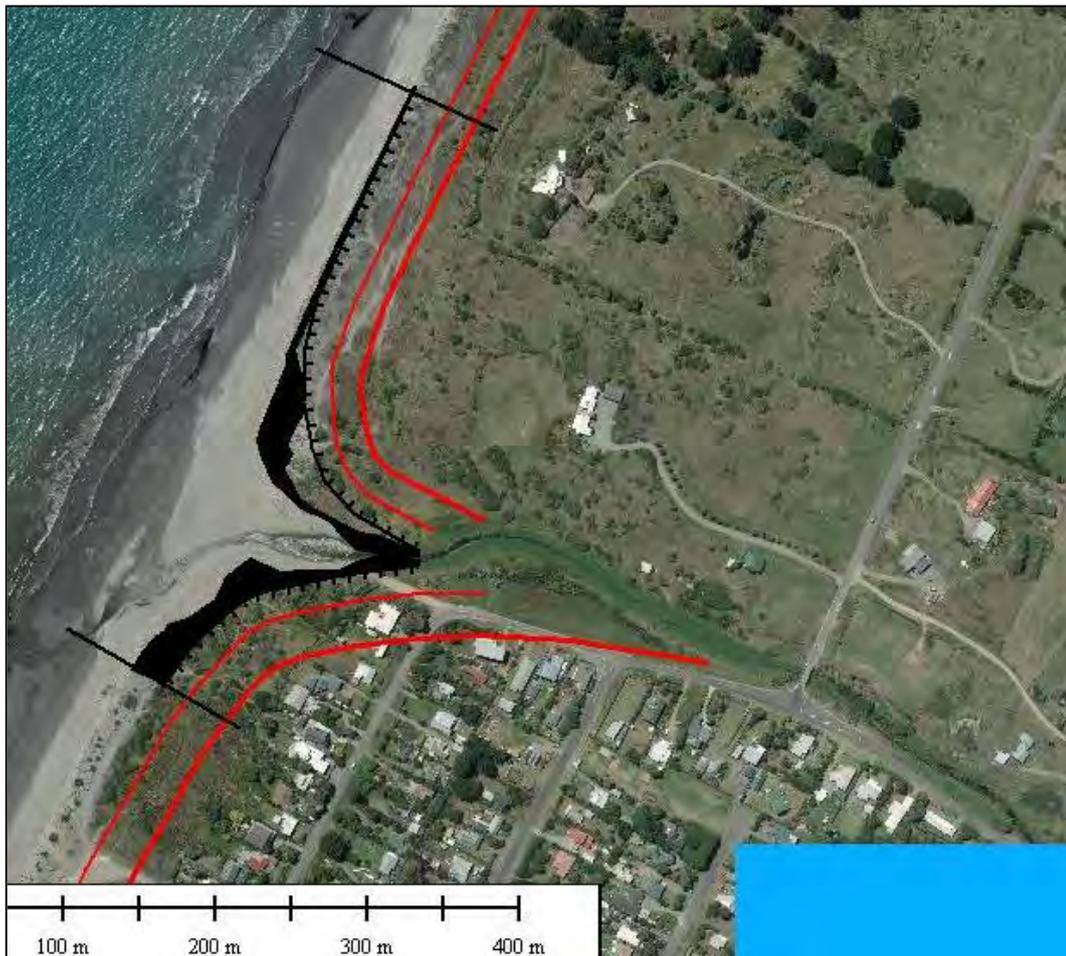
Figure 1 Mangaone erosion assessment analysis for managed inlet 50 and 100 yr scenarios. The black areas depict the shoreline envelop for 1993 to 2013 samples out to the GWRC trigger lines (marked by black lines) used to initiate a mouth cut (realignment). The racked black lines define the inlet migration curves, while the thin and thick red lines define the 50 and 100 yr erosion hazard prediction lines respectively.

The analysis output for 1993 to 2013 shoreline data is depicted in Figure 1. As can be seen, no dwellings are affected using these data under the 50 yr assessment period, while output for the 100 yr period affects one dwelling and a small part of two others. Using 1980 to 2013 data gives the same result as the inlet migration curve remains unchanged in the vicinity of these particular dwellings.
