# Empirical modelling of run-up and overtopping at a boulder beach, Raglan, New Zealand

Tom D. Shand<sup>1</sup>, Richard A. Reinen-Hamill<sup>1</sup>, Roger D. Shand<sup>2</sup> and Wouter Viljoen<sup>3</sup>

<sup>1</sup>Tonkin & Taylor Ltd, Auckland, NZ. [tshand@tonkin.co.nz](mailto:tshand@tonkin.co.nz), [rreinenhamill@tonkin.co.nz](mailto:rreinenhamill@tonkin.co.nz)

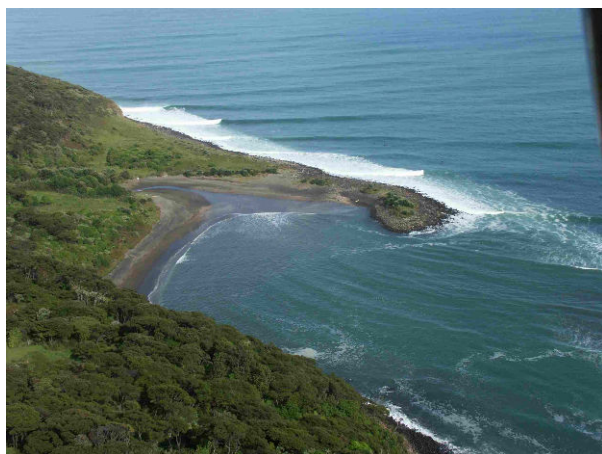
Figure 1 Boulder bank at Whale Bay, Raglan (Source: Skyworks Waikato, 2005).

The barrier spit is comprised of boulders ranging from 300mm to over 1m in diameter. The intertidal seaward face of the barrier spit has slopes between 5(H):1(V) and 7(H):1(V). This is a fairly typical slope for materials of this size. The slope then decreases to near horizontal on a berm located at around the low tide mark before steepening again to around 10(H):1(V) to 15(H):1(V). This slope continues fairly consistently offshore. The backshore region is near horizontal and heavily vegetated with shrubs and grasses.

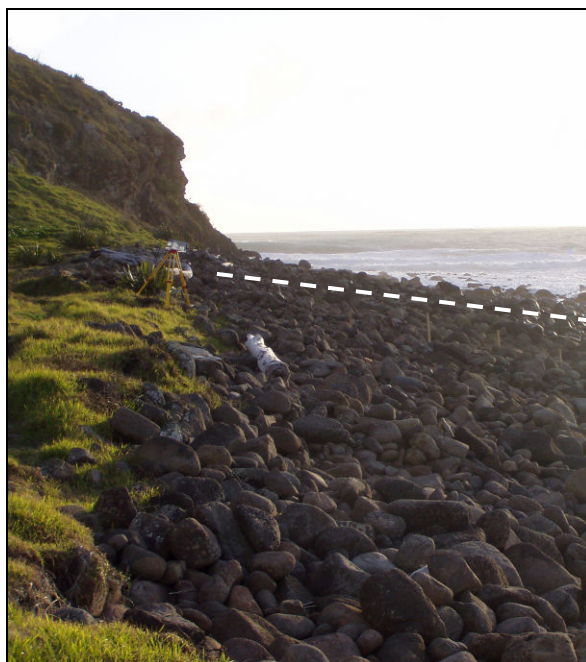
Figure 2 Video camera and run-up marker setup

First a transect line in the direction of incident wave run-up was surveyed down the boulder bank and wooden stakes placed every 0.5m vertical elevation change (refer Figure 2). This transect line was selected as being the critical flow path for water overtopping the boulder bank and posing a risk to the future dwelling. The placement of the stakes enabled the maximum extent of run-up to be accurately determined.

As the run-up elevation corresponding to the level exceeded by the largest 2% of waves was required, data was analysed over a predetermined period of time based on the mean wave period. For example, if a mean wave period of 12s was determined on-site, the average time taken for 50 waves to arrive is 600s or 10min. By selecting the largest run-up elevation collected every 10min over a 1 hour period and averaging subsequent data-sets, a mean value of  $R_{2\%}$  could be extracted. A video camera setup aimed along the transect line was used to record run-up elevations using a 'time-stack' method.

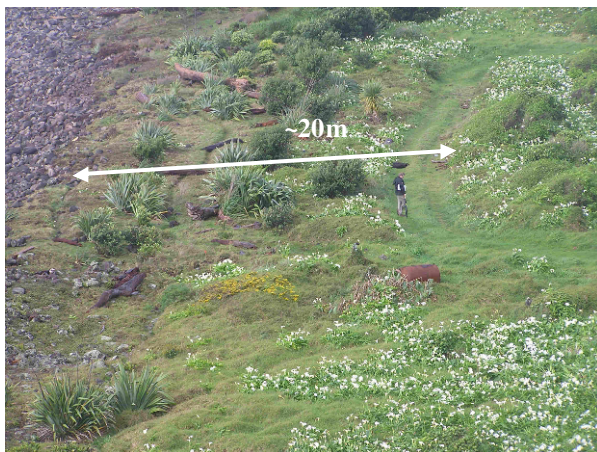
Figure 6 Distance from crest to over-wash debris from the September 2005 storm event. Photo: Eco Nomos Ltd

Observation showed that some overtopping of the boulder bank crest occurred (refer Figure 6). However, there was a general lack of damage to vegetation beyond the crest, and minimal die-back subsequently occurred; both of which suggest that only a few waves actually overtopped the crest.

These values agree reasonably with the observed distance that material was transported by overtopping

during the storm event as described by Eco Nomos, 2005 (refer Figure 6).
