Empirical modelling of run-up and overtopping at a boulder beach, Raglan, New Zealand

Tom D. Shand¹, Richard A. Reinen-Hamill¹, Roger D. Shand² and Wouter Viljoen³

¹Tonkin & Taylor Ltd. Auckland, NZ. tshand@tonkin.co.nz, rreinenhamill@tonkin.co.nz

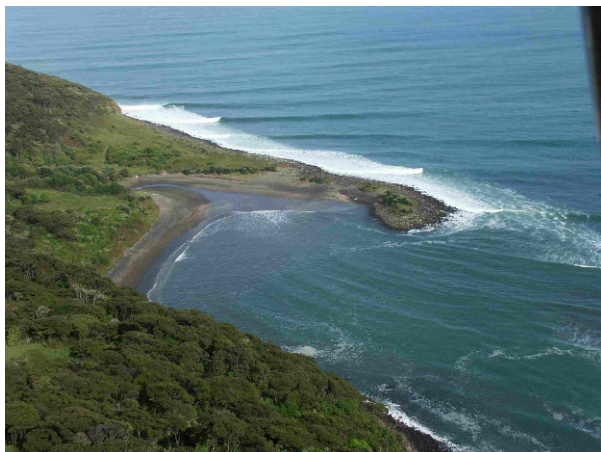
Figure 1 Boulder bank at Whale Bay, Raglan (Source: Skyworks Waikato, 2005).

The barrier spit is comprised of boulders ranging from 300mm to over 1m in diameter. The intertidal seaward face of the barrier spit has slopes between 5(H):1(V) and 7(H):1(V). This is a fairly typical slope for materials of this size. The slope then decreases to near horizontal on a berm located at around the low tide mark before steepening again to around 10(H):1(V) to 15(H):1(V). This slope continues fairly consistently offshore. The backshore region is near horizontal and heavily vegetated with shrubs and grasses.

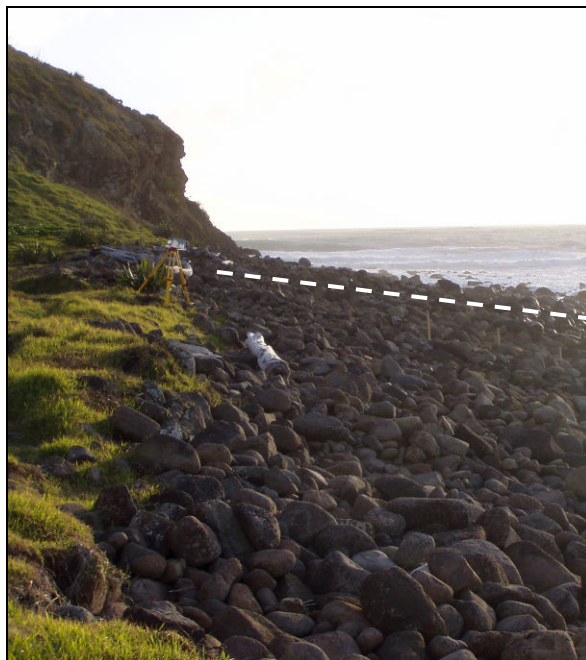
Figure 2 Video camera and run-up marker setup

First a transect line in the direction of incident wave run-up was surveyed down the boulder bank and wooden stakes placed every 0.5m vertical elevation change (refer Figure 2). This transect line was selected as being the critical flow path for water overtopping the boulder bank and posing a risk to the future dwelling. The placement of the stakes enabled the maximum extent of run-up to be accurately determined.

As the run-up elevation corresponding to the level exceeded by the largest 2% of waves was required, data was analysed over a predetermined period of time based on the mean wave period. For example, if a mean wave period of 12s was determined on-site, the average time taken for 50 waves to arrive is 600s or 10min. By selecting the largest run-up elevation collected every 10min over a 1 hour period and averaging subsequent data-sets, a mean value of $R_{2\%}$ could be extracted. A video camera setup aimed along the transect line was used to record run-up elevations using a ‘time-stack’ method.

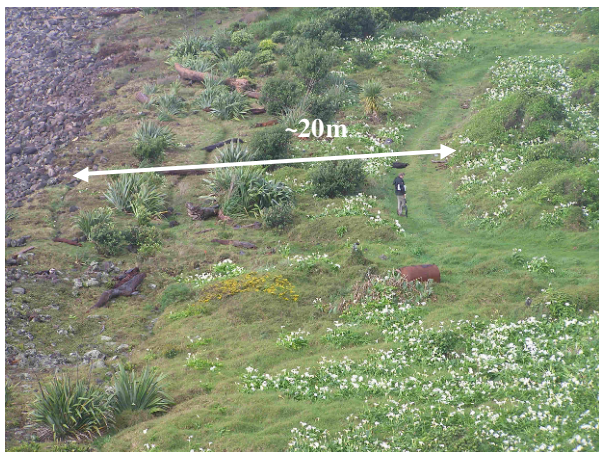
Figure 6 Distance from crest to over-wash debris from the September 2005 storm event. Photo: Eco Nomos Ltd

Observation showed that some overtopping of the boulder bank crest occurred (refer Figure 6). However, there was a general lack of damage to vegetation beyond the crest, and minimal die-back subsequently occurred; both of which suggest that only a few waves actually overtopped the crest.

These values agree reasonably with the observed distance that material was transported by overtopping

during the storm event as described by Eco Nomos, 2005 (refer Figure 6).
