# Environmental implications of a proposed channel excavation for boat access near the Rangitikei Rivermouth

Report prepared for Mr John Grice, Tangimoana Boating Club

**Client Report 06/03**

**July 2006**

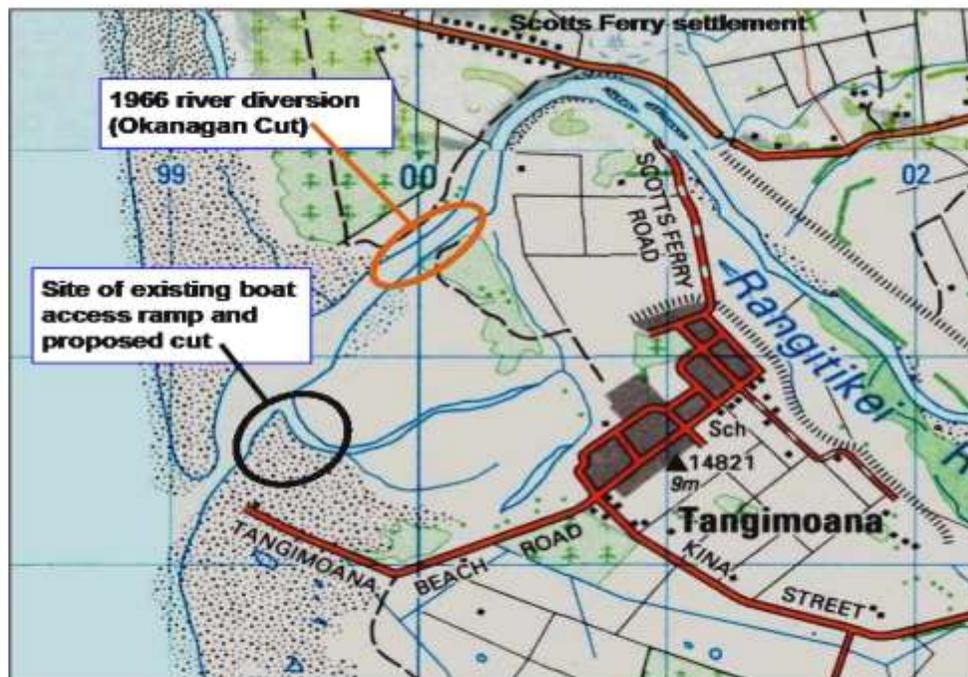
Figure 1 Topographic map of the Rangitikei Rivermouth area showing the site of the proposed cut and location of the 1966 river diversion.

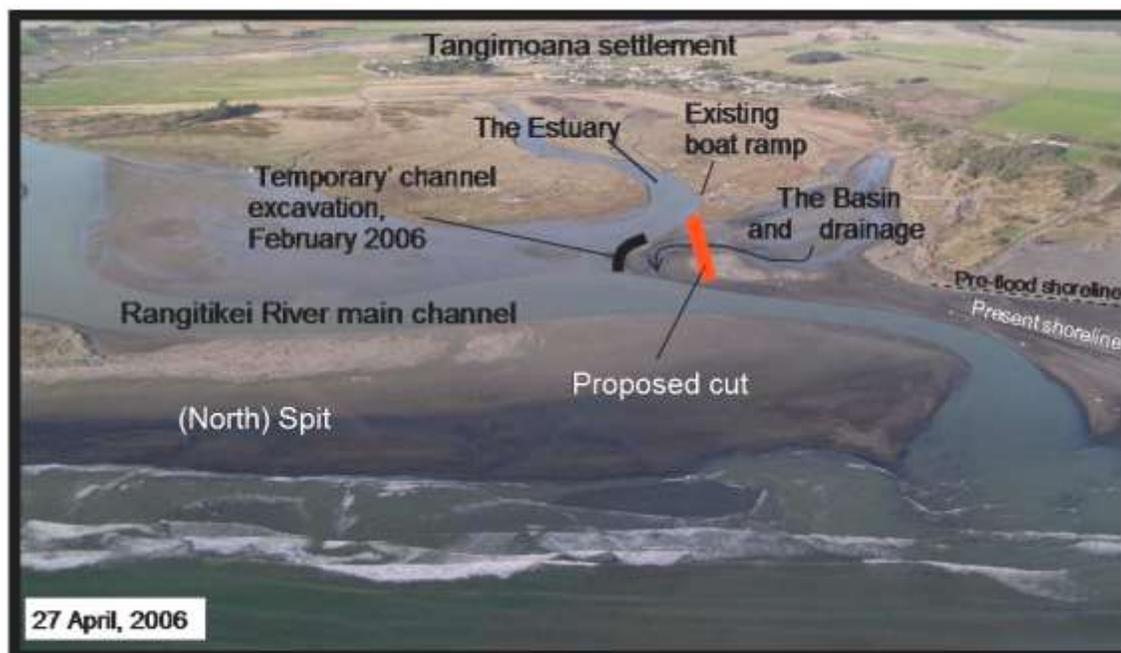
Figure 2 Natural features, boating utilities and location of the proposed cut near the mouth of Rangitikei Rivermouth.

The old river bed has slowly infilled and the seaward channel remnants are locally referred to as the 'Estuary' and the 'Basin' (see Fig 2). The Basin has undergone greater infill due to its closer proximity to the coastal sand supply which blew directly into the Basin and was also transported upstream under the action of waves and flood currents to reach the Basin. In addition, sand was/is then blown further up the Basin where sediments of fluvial origin (silts) are also deposited during higher tides or during floods. By contrast the Estuary remains a tidal channel.

Further significant morphological change was associated with the February 2004 flood which breached the spit. Since that time the entrance has migrated back toward the south. These more recent changes can be appreciated by studying oblique aerial photos taken on 1 August, 2004, some 6 months after the flood (e.g. see Fig 8), and the oblique photos taken in April of this year (e.g. see Fig 2). In particular:

- At the mouth of the Rangitikei River, some of the old north spit sediment also merged directly to the mouth of the Basin (Fig 8). This sediment input has blocked drainage from the Basin and this has been redirected toward the Estuary as depicted in Fig 2.

The 2006 oblique air photo (Fig 2) indicates that the seaward end of the shoal may be extending toward the mouth of the Estuary, although vertical aerial photos are needed for confirmation. However, if this is indeed the case, then such a process may also contribute, either now or in the future, toward infill of the Estuary mouth.

The cut will cross the present drainage outlet from the Basin as marked in Fig 2. The Basin's drainage has been deflected toward the Estuary following the recent sediment accumulation associated with merging of the north spit. Having the basin drainage join the new channel may compromise the hydraulic efficiency of the cut and hasten its infill.

The temporary channel (Fig 2) excavated through infill at the mouth of the estuary last February is still functional through the mid to upper part of the tidal cycle. This channel is ~100 m long. Increasing the depth by say 1 m and the width by say 5 m would allow boat access throughout the tidal cycle. This deepening of the existing channel amounts to a partial 'reinstatement' of the pre-flood channel at the mouth of the Estuary. While this alternative will still be subject to the same sedimentation problems as the proposed cut, there are several advantages with this smaller-scale option.

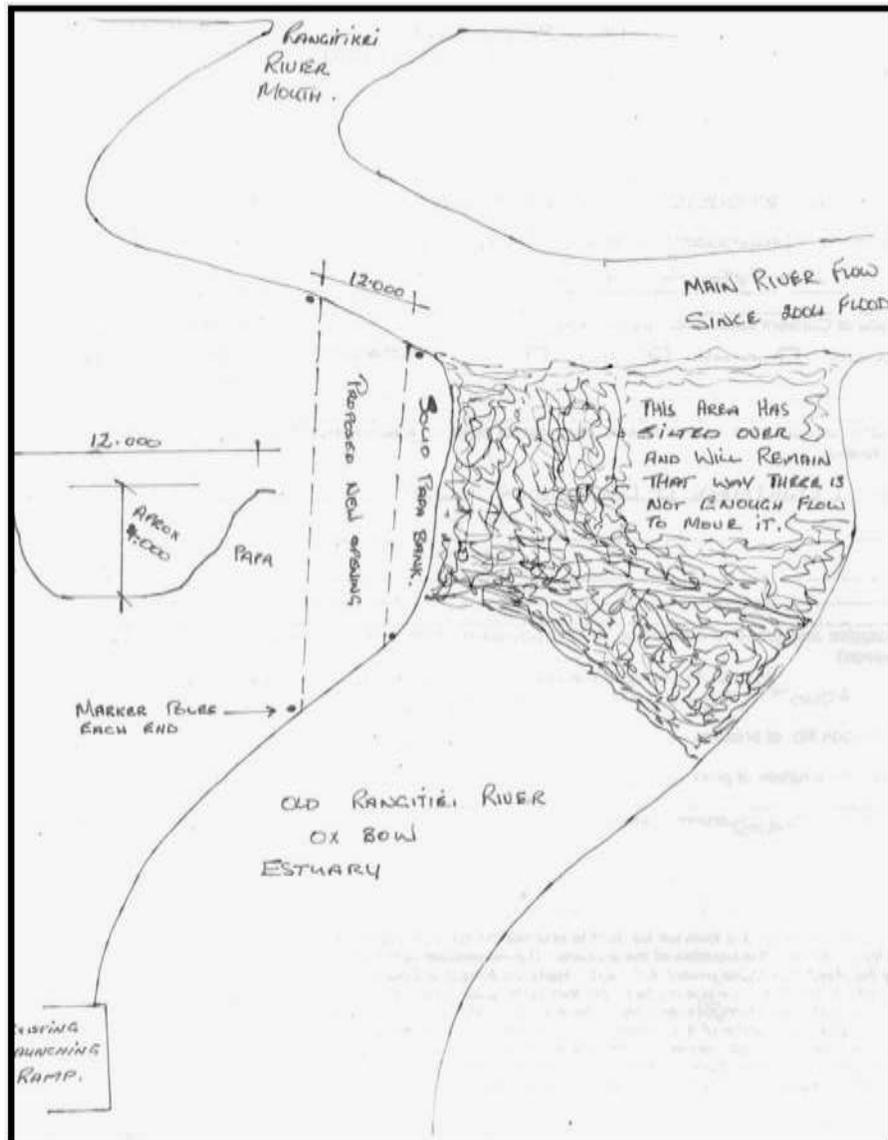
**Figure 3 Sketch of the proposed cut as attached to the Tangimoana Boating Club's resource consent application.**

On 4 November, 2005, an application for a resource consent to excavate the bed of the Rangitikei River was made to Horizons Regional Council by Mr John Grice on behalf of the Tangimoana Boating Club. The excavation was to cut a new boat access channel between the existing boat ramp and the main channel (see Figs 1 and 2). The proposed cut would be approximately 270 m long by 12 m wide by 4 m deep, with (side) batters at ~20 degrees. Details of the excavation, as sketched in the resource consent application, are shown in Fig 3.

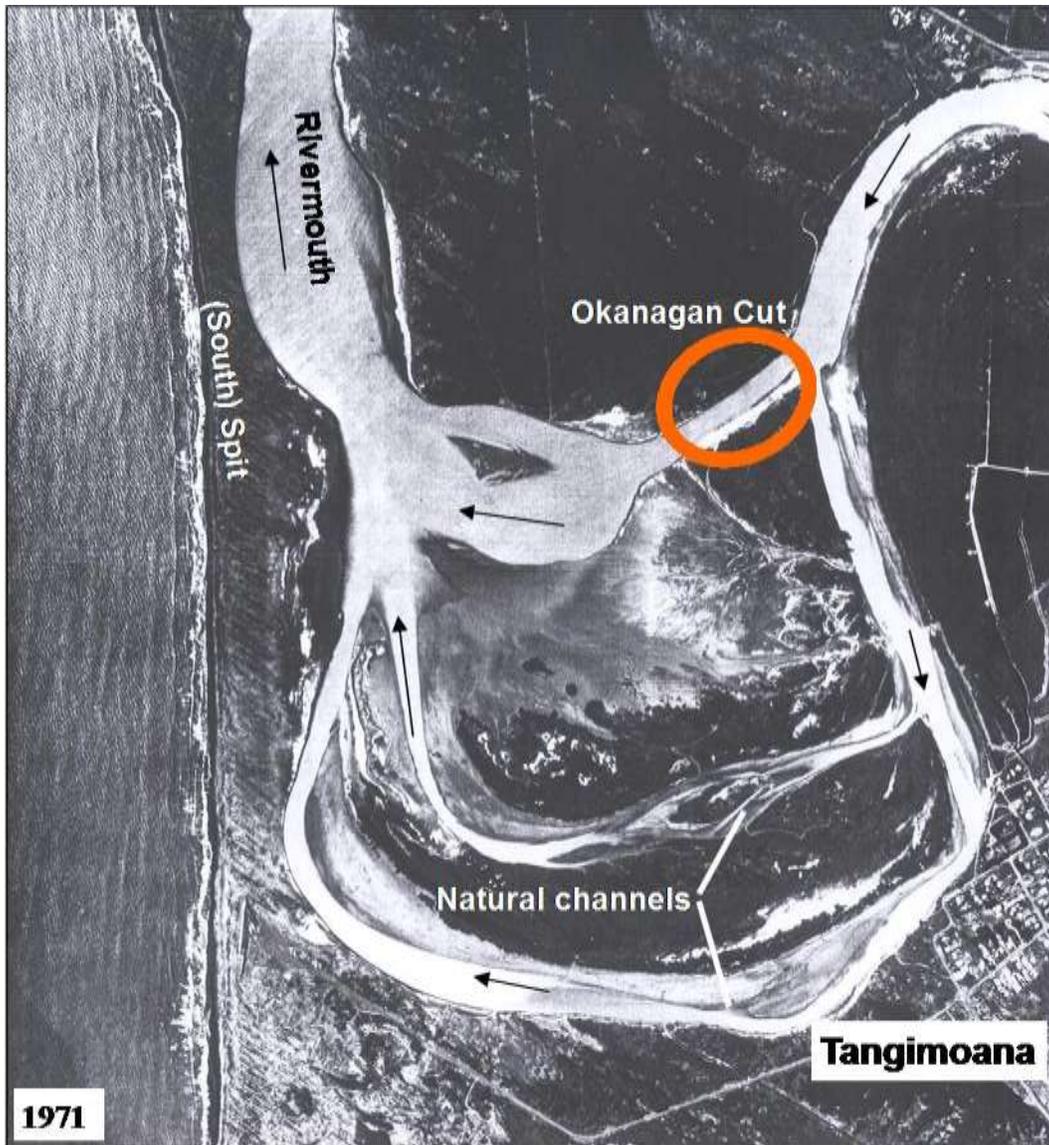
**Figure 4** Lower river simultaneously flowing through the original (natural) channels at bottom of this 1971 photo, and through the Okanagan Cut made in 1966. For several years both the natural and diversion channels operated.

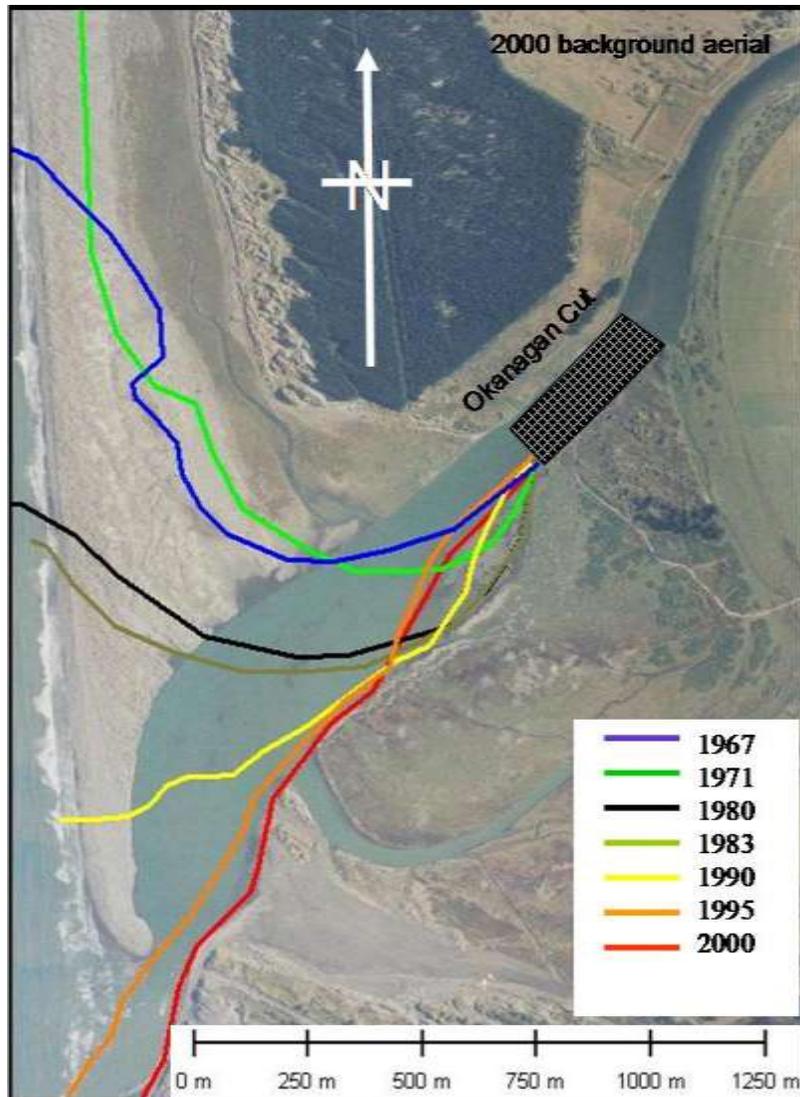
Figure 5 Systematic southward migration of the left bank of the main river channel since opening of the Okanagan Cut in 1966.

The most significant morphological change resulting from the Okanagan Cut, as evident in the sample of aerial photographs available to the author, has been the systematic migration of the main channel from a northern entrance (and south spit) to a southern entrance (and north spit). This process is illustrated in Fig 5 which depicts the behaviour of the true left bank.

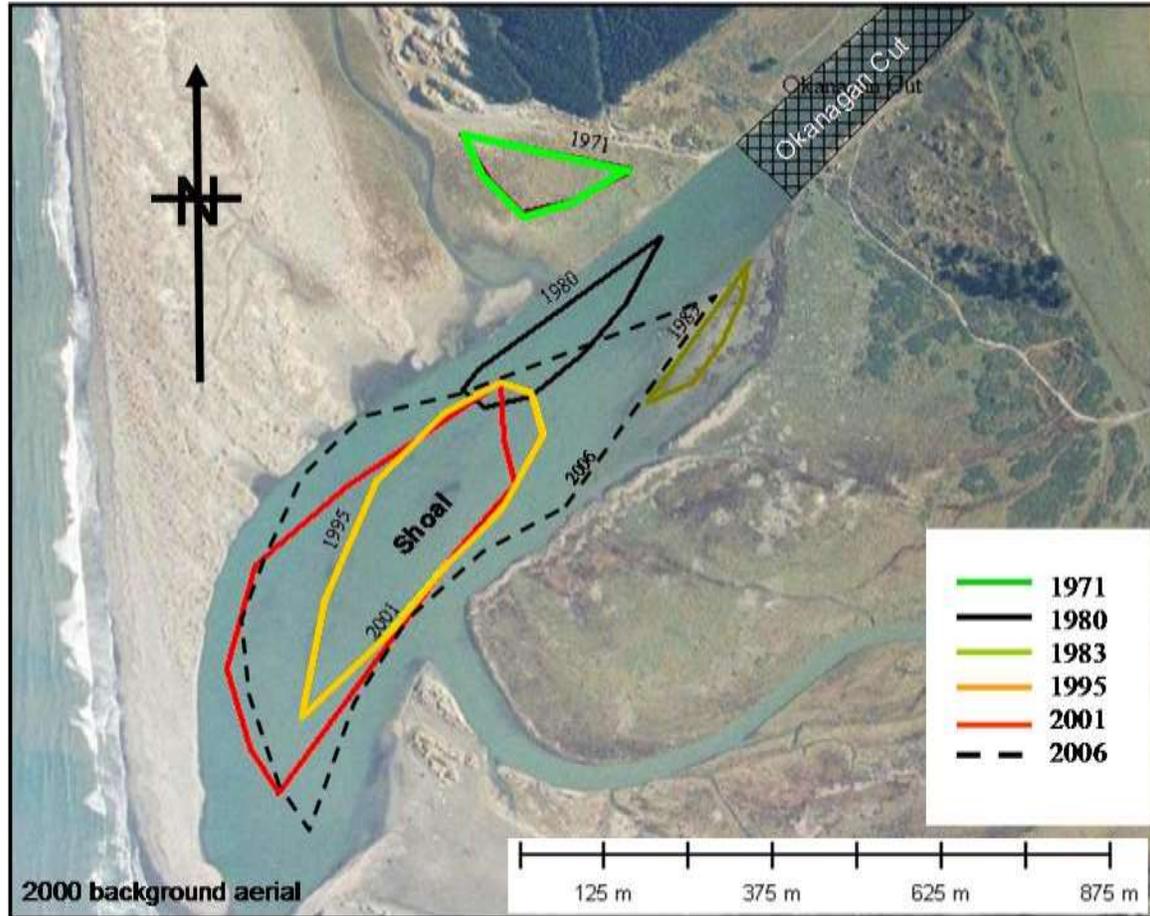
**Figure 6** Development of the shoal below the Okanagan Cut based on aerial photographs. Location of the shoal margins are influenced by tide and river levels at time of photography. Note the 2006 outline is approximated from the 2006 oblique aerial.

A further morphological change has been the ongoing development of a shoal downstream of the Okanagan Cut (Fig 6). Shoals often occur downstream of a flow constriction as deposition accompanies the drop in velocity. The flow can then bifurcate, i.e. fork with channels running along each bank. Over time, one channel tends to predominate and the other may infill. Such a process is indicated in Fig 6. While different water levels at the time photographs were taken mean that these data only

provide an indication of shoal dimensions, the spatial extent does appear to be increasing. While there were no post-flood vertical aerials available to the author at the time of writing this report, the 2006 oblique aerial (see Fig 7) indicates that the shoal is extending toward the north and that the right bank is eroding.

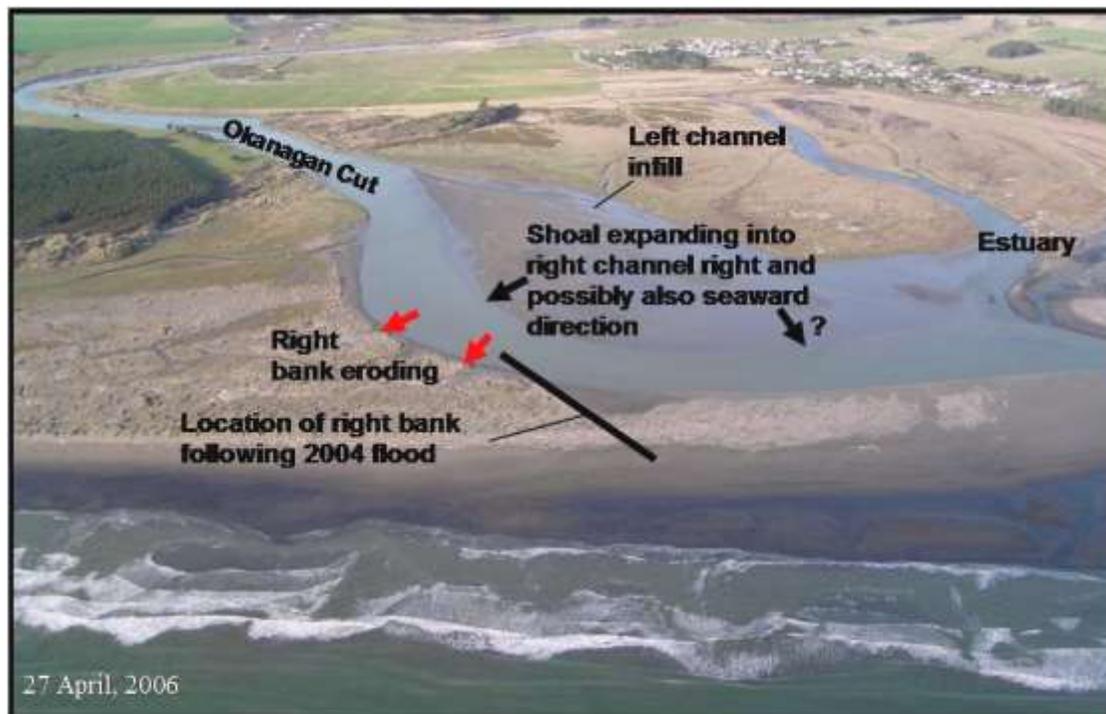
**Figure 7 Channel processes occurring at the present time between the Okanagan Cut and the Estuary.**

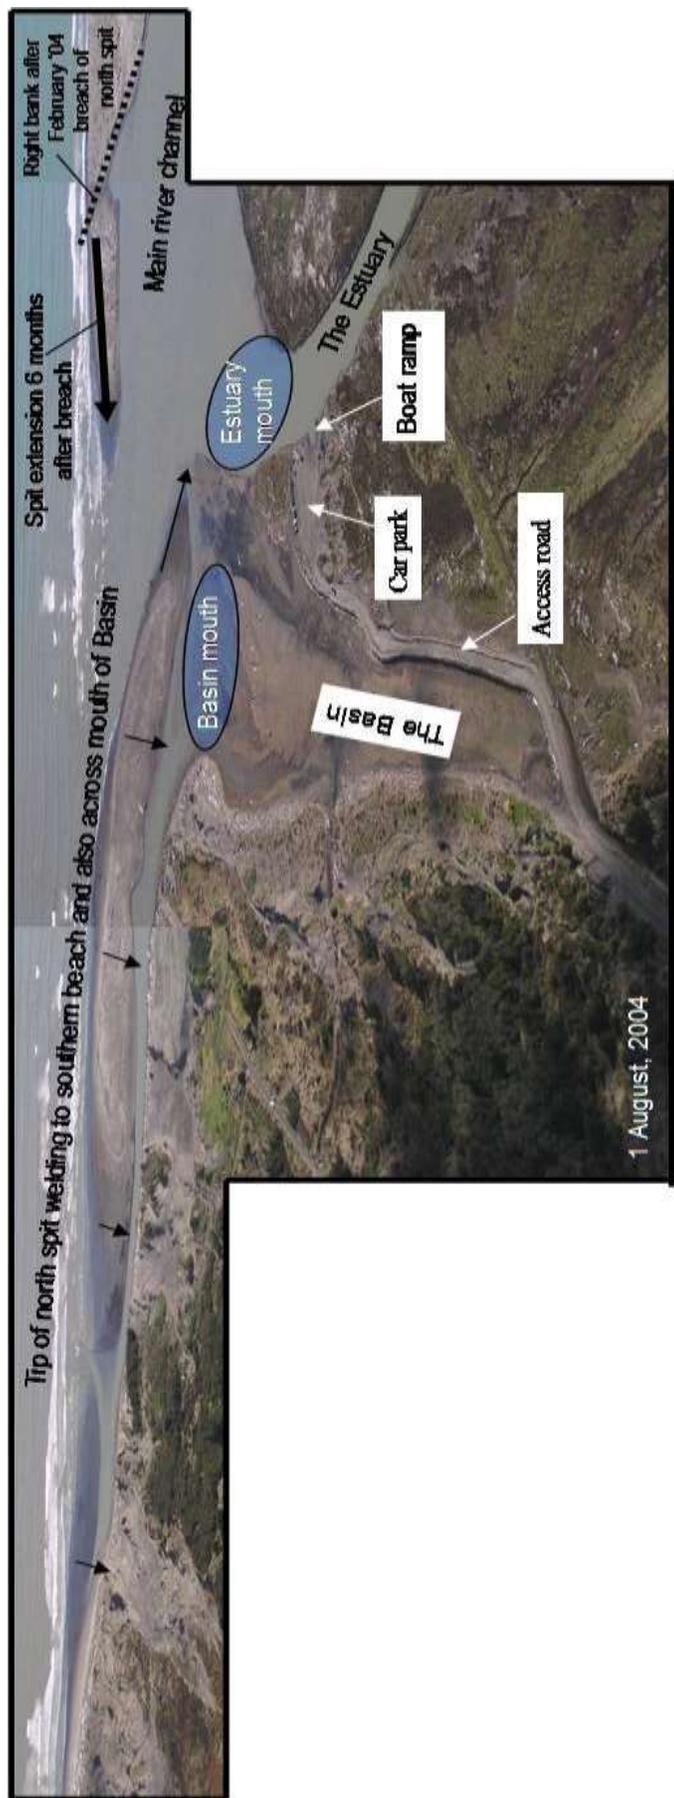
Figure 8 Existing utilities, and morphological processes 6 months after the extreme flood event in February 2004.

- The section of the (north) spit detached by the breach subsequently migrated onshore under wave action and merged to the southern beach (Fig 8), which consequently underwent a dramatic increase in width (Fig 2). It is noted that breaching of rivermouth spits during a flood, and the subsequent merging of the tip with the adjacent beach, is a well recognized mechanism by which littoral sediment bypasses an entrance. Furthermore, the dramatic input of sediment onto the south coast is now available to be blown inland and this will cause dune instability if the growth of dune grasses is unable to keep pace with the rate of sand deposition.

In 2002-03 access switched to the Estuary with a slipway being constructed, along with a metalled accessway and car park (see Fig 8). River/sea access via the Estuary worked well until the 2004 flood after which the entrance to the Estuary has been infilling. In February of this year, a small cut was excavated within the Estuary mouth (see Fig 2) to allow boat access for the club's annual fishing contest. This channel was expected to provide a 'temporary solution'. The present proposal to bypass the Estuary mouth is the latest move to ensure boat access.

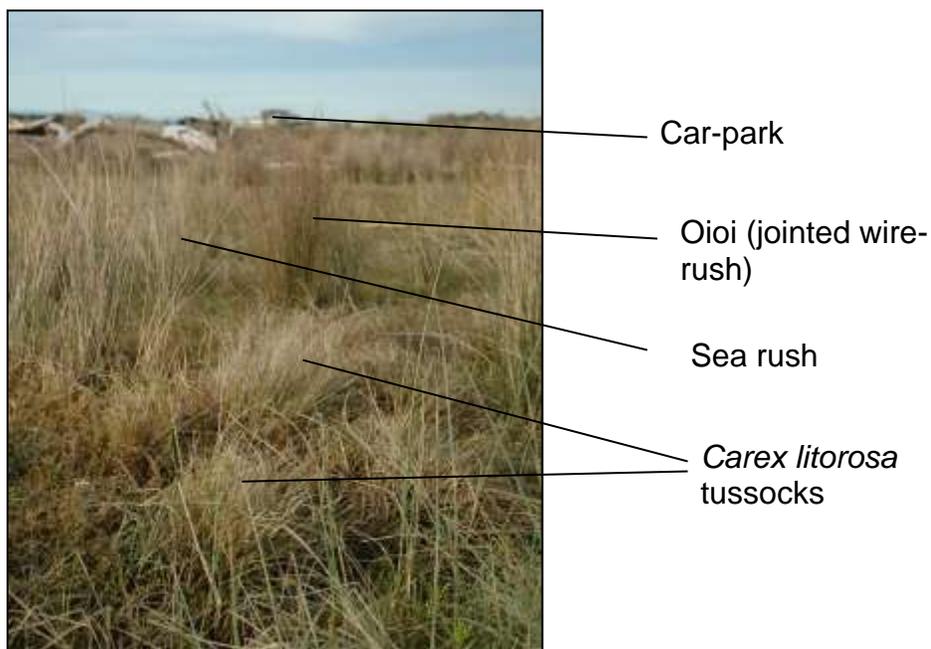
Salt marsh vegetation containing *Carex litorosa*, about 20 m from car-park for Tangimoana boat-ramp

Immediately seaward of the carpark/boat launch ramp, I found numerous plants of a native sedge, *Carex litorosa*, which has a national conservation status of 'Chronically threatened – serious decline'. Nationally, its habitat is exclusively saltmarshes where it forms tussocks to about 30 cm tall. It has a history of local extinctions e.g. the Hutt River estuary in 1950s or 1960s, the Waikanae estuary since about 1975,

At Tangimoana, my guesstimate is that at least 200 plants of *C. litorosa* exist between the carpark and the main river channel. This area includes the proposed cut. Immediately upriver (east) from the carpark I found dozens more *C. litorosa*, this time among dense sea rush and shorter stature succulent plants such as a native saltmarsh celery (*Apium 'filiforme'*), and a button daisy (*Leptinella dioica* ssp. *dioica*). It is almost certain that the construction of the carpark will have eliminated many plants of *C. litorosa* and other saltmarsh plants. Although a reasonable estimate of the loss could be made from calculating the densities of *C. litorosa* immediately up and down stream from the carpark then measuring the area of the carpark and boat-ramp, this is probably not useful after the event. The main issue is to protect the remaining population which seems particularly suited to this environment.

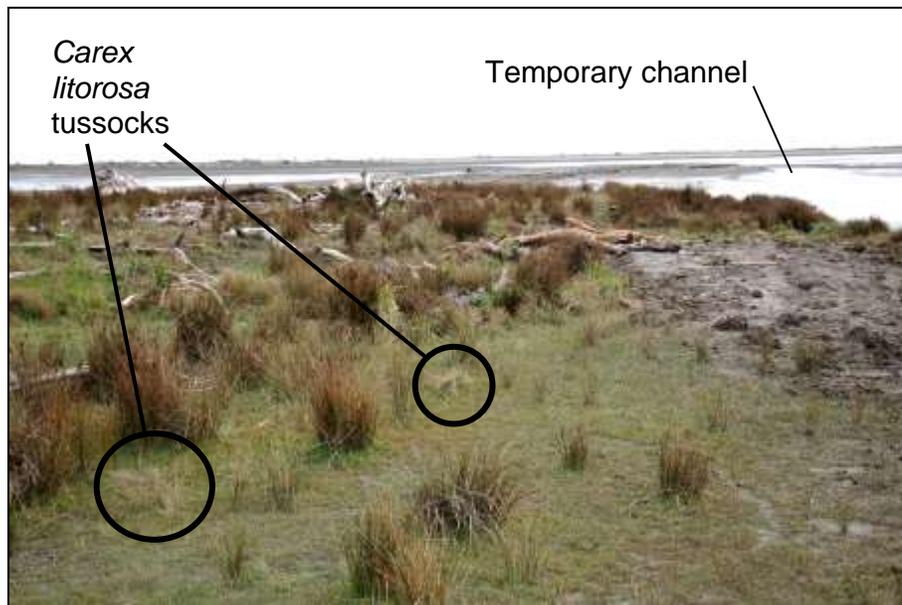
View towards coast from boat-ramp car-park,  
in vicinity of proposed new channel

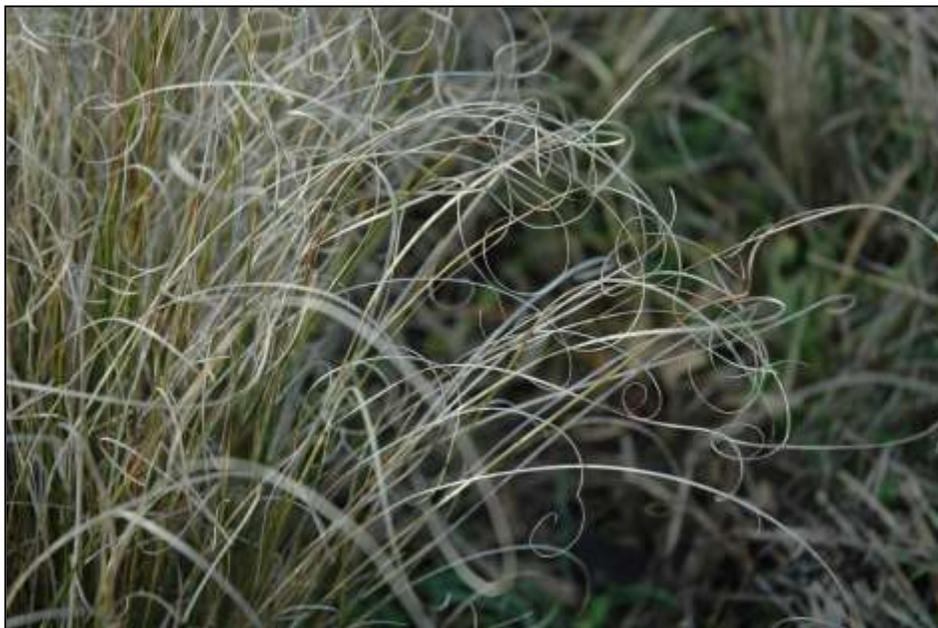
*Carex litorosa* at Tangimoana 20 m from boat-ramp car-park.  
The curled leaf tips are a feature of this sedge

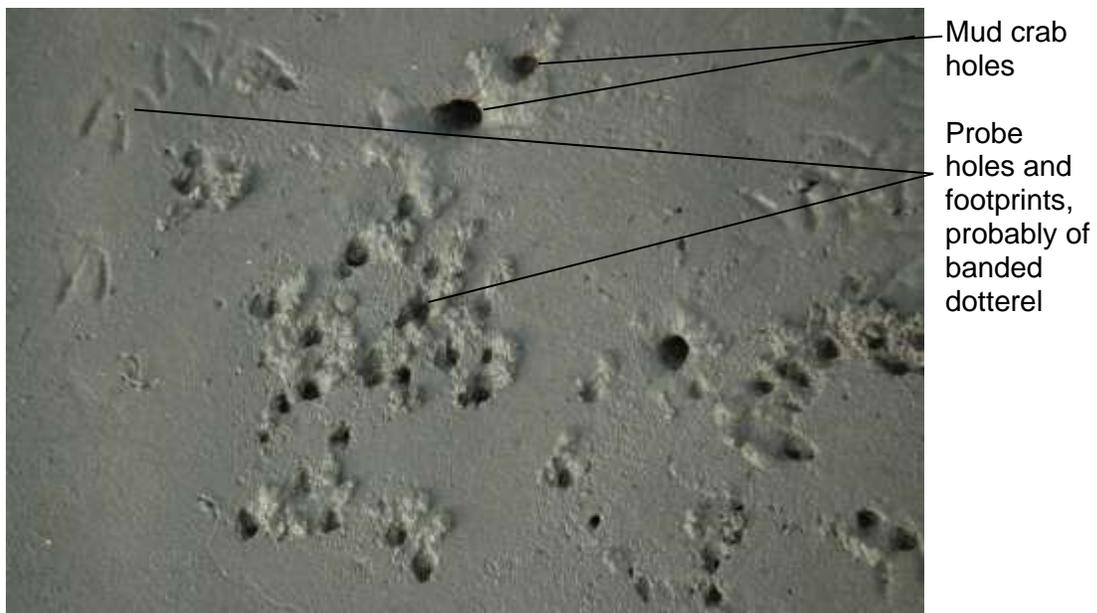
Holes of mud crab and probably banded dotterel probings,  
Tangimoana estuary – unvegetated mudflats on route of  
proposed new channel

Gathering data on birds from a single visit to any site is insufficient to form a sound opinion as to that site's significance for birds. However, I was impressed by both the numbers and variety of waders and other wetland birds I saw in the estuary on our visit. They included 10 banded dotterel, 1 variable oystercatcher, 3 royal spoonbills, > 20 pied stilts, 1 white-faced heron, 4 eastern bar-tailed godwits, > 500 black-backed gulls, several unidentified shags, a kingfisher (on the mud flat), black swans and mallards. This is a greater variety and, for some, with greater numbers, than I would expect to see at the Whanganui Estuary at the same time of year. In some of the mudflats we crossed there were many crab holes and plenty of footprints of wading birds (probably banded dotterels).

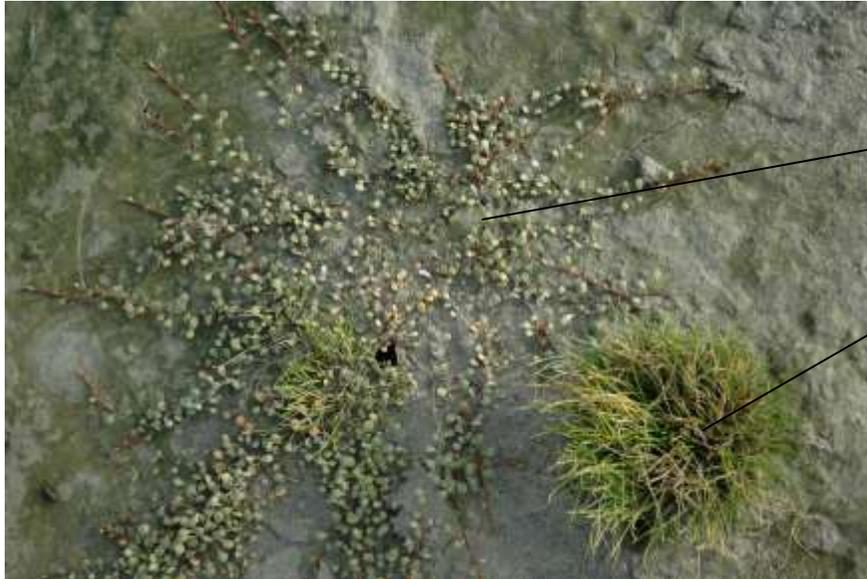
Saltmarsh on soft silt, 'The Basin', Tangimoana, Rangitikei  
River estuary

In the general area under consideration, I noted a number of different plant communities that could all be called collectively 'saltmarsh vegetation'. On soft fine silts in the Basin between the carpark causeway and the access road to the beach is sparse vegetation composed almost solely of a small tufted sedge, *Isolepis cernua* and sea primrose (*Samolus repens*). Slightly more elevated areas with sand and firmer silt contained a larger variety of taller plants. A creeping sand sedge (*Carex pumila*) occupied the most sandy areas, but it also grew among taller vegetation comprising sea rush (*Juncus kraussii*) and three-square (*Schoenoplectus pungens*) with scattered plants of oioi or jointed rush (*Apodasmia similis*).
