2014-15 LRep  
25 November, 2014

Prepared for:  
Tonkin and Taylor Ltd

## **Cooks Estuary (Longreach Subdivision) Erosion Hazard Assessment**

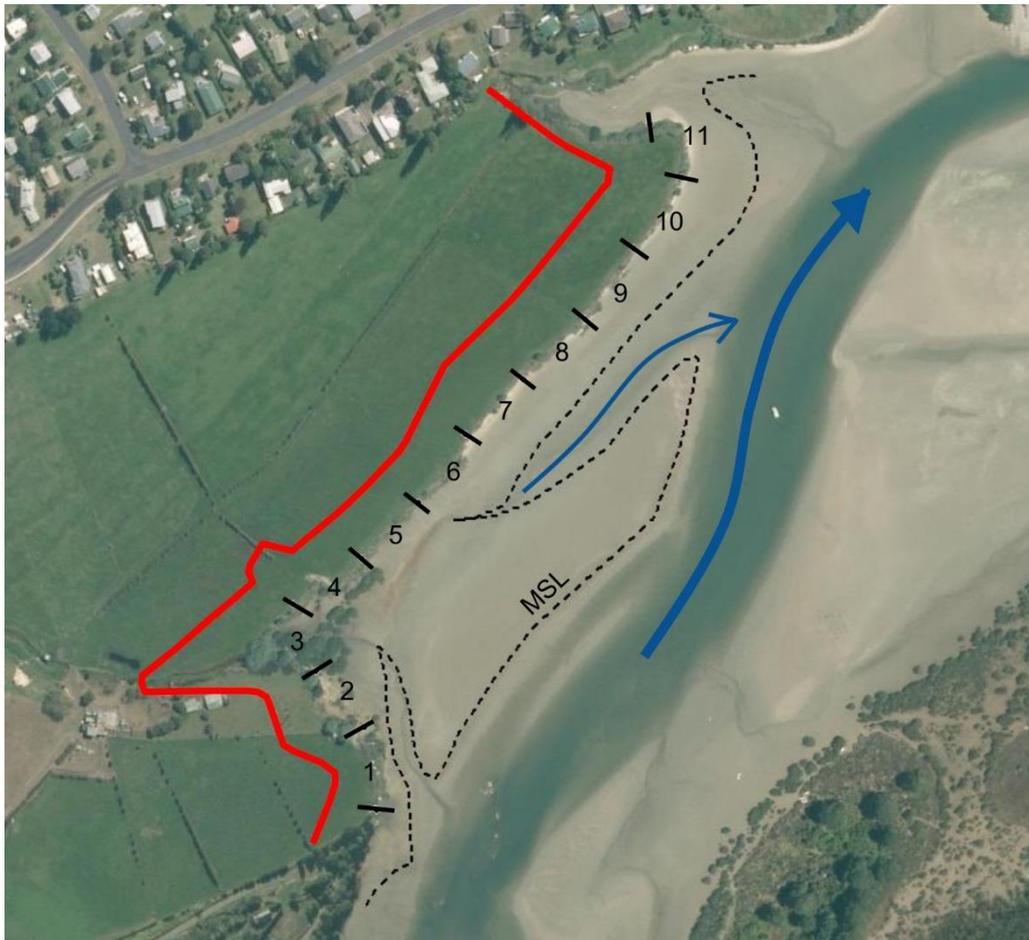
**Figure 1** One hundred year erosion hazard line (red) on 2012-13 aerial photo. Sampling sectors 1 to 11 marked. MSL depicted by dashed line. The tick blue arrow marks the Purangi River while the thin blue arrow marks a secondary channel closer to the subdivision shoreline.

The 550 m long subdivision fronting the estuary was divided into 11 x 50 m long segments or sectors and numbered from the upstream end (Figure 1).

The estuary bars, mud flats and channels appear particularly stable throughout the historical aerial record, and also on the earlier survey plans. Fronting the subdivision the main channel lies some 50 m off the western shoreline (sector 1), 130 m from the central sector shoreline (sectors 3 to 6) then reduces to 60 m fronting sectors 10 and 11 (see Figure 1). The closer proximity of the main channel in the eastern sectors correspond with a secondary channel closer to the shoreline that increases in size adjacent to Sectors 6-7, and this morphological change appears to have consequence for shoreline stability described below. The recent occurrence of mangroves, evident in the western sectors in the 1996 and 2012-13 aerial photos, may modify sedimentation

The final **erosion prediction distance** thus consists of the longer-term shoreline change (less historical SLR retreat), plus retreat from predicted SLR, with their sum being multiplied by 1.5 (final column in Table 1). The results define two distinct reaches with the partition occurring between sectors 6 and 7 and this appears related to estuary morphology as described earlier. Overall the estuary morphology appears to be relatively stable indicating erosion extrapolation/prediction over a 100 yr time period can occur with some confidence. The maximum value for each reach was used to represent all sectors to further account for the range of uncertainty; in particular sectors 2 to 6 = 25 m, while sectors 7 to 10 = 35 m with the upstream value being 17 and the downstream extreme value being 39 m. The resulting **erosion hazard line** is depicted in Figure 1.
